Updates and Features

New Showerfeed Rotary Block

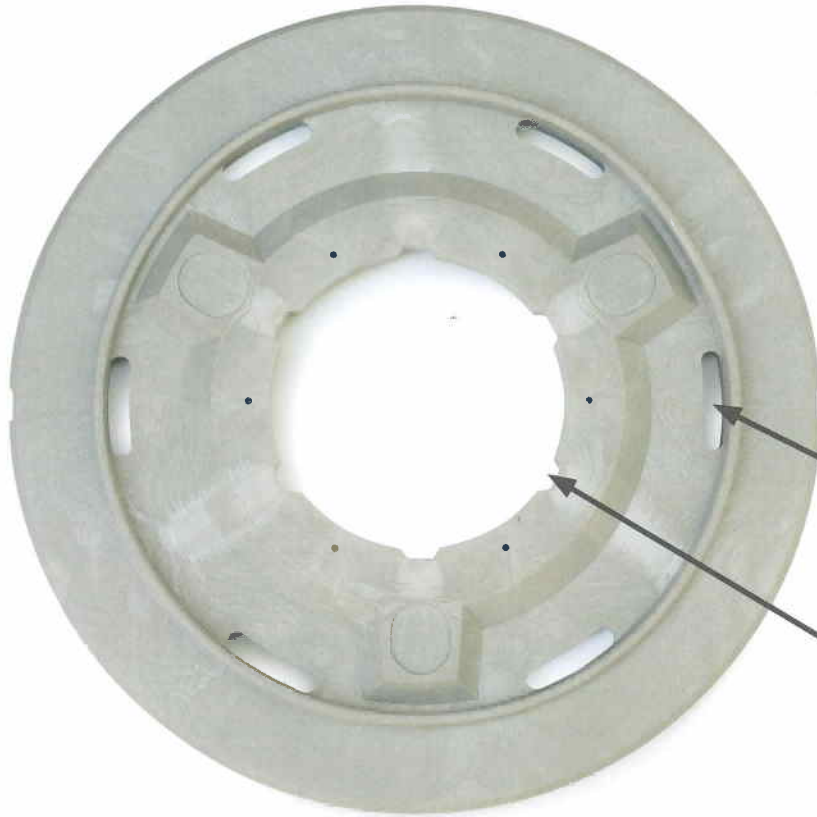
Solution feed holes have been redesigned for better usage and a more even coverage. This improvement alone proved to be 10 times more effective at directing solution for utilization.

New interlocking splined design increases the durability of the riser and the block.

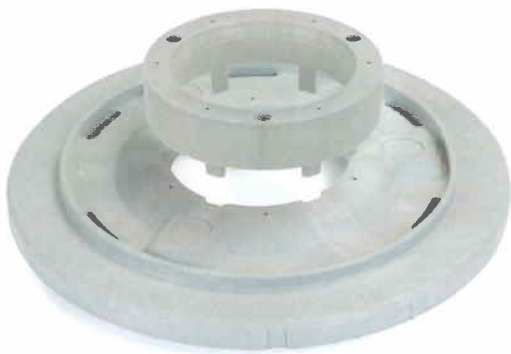
Riser Installation

This image shows how the added splines aid in the installation of the Riser onto the new Rotary Brush Block. Stainless steel fasteners are included to secure the connection between the two.
